OPERATION REDWING - PROJECT 5.9

WEAPON EFFECTS ON MISSILE STRUCTURES AND MATERIALS (U) SANITIZED VERSION

C. J. Cosenza, Lt, USAF, Project Officer
G. W. Mills
G. J. Roth

Aircraft Laboratory
Wright Air Development Center
Wright-Patterson Air Force Base
Dayton, Ohio

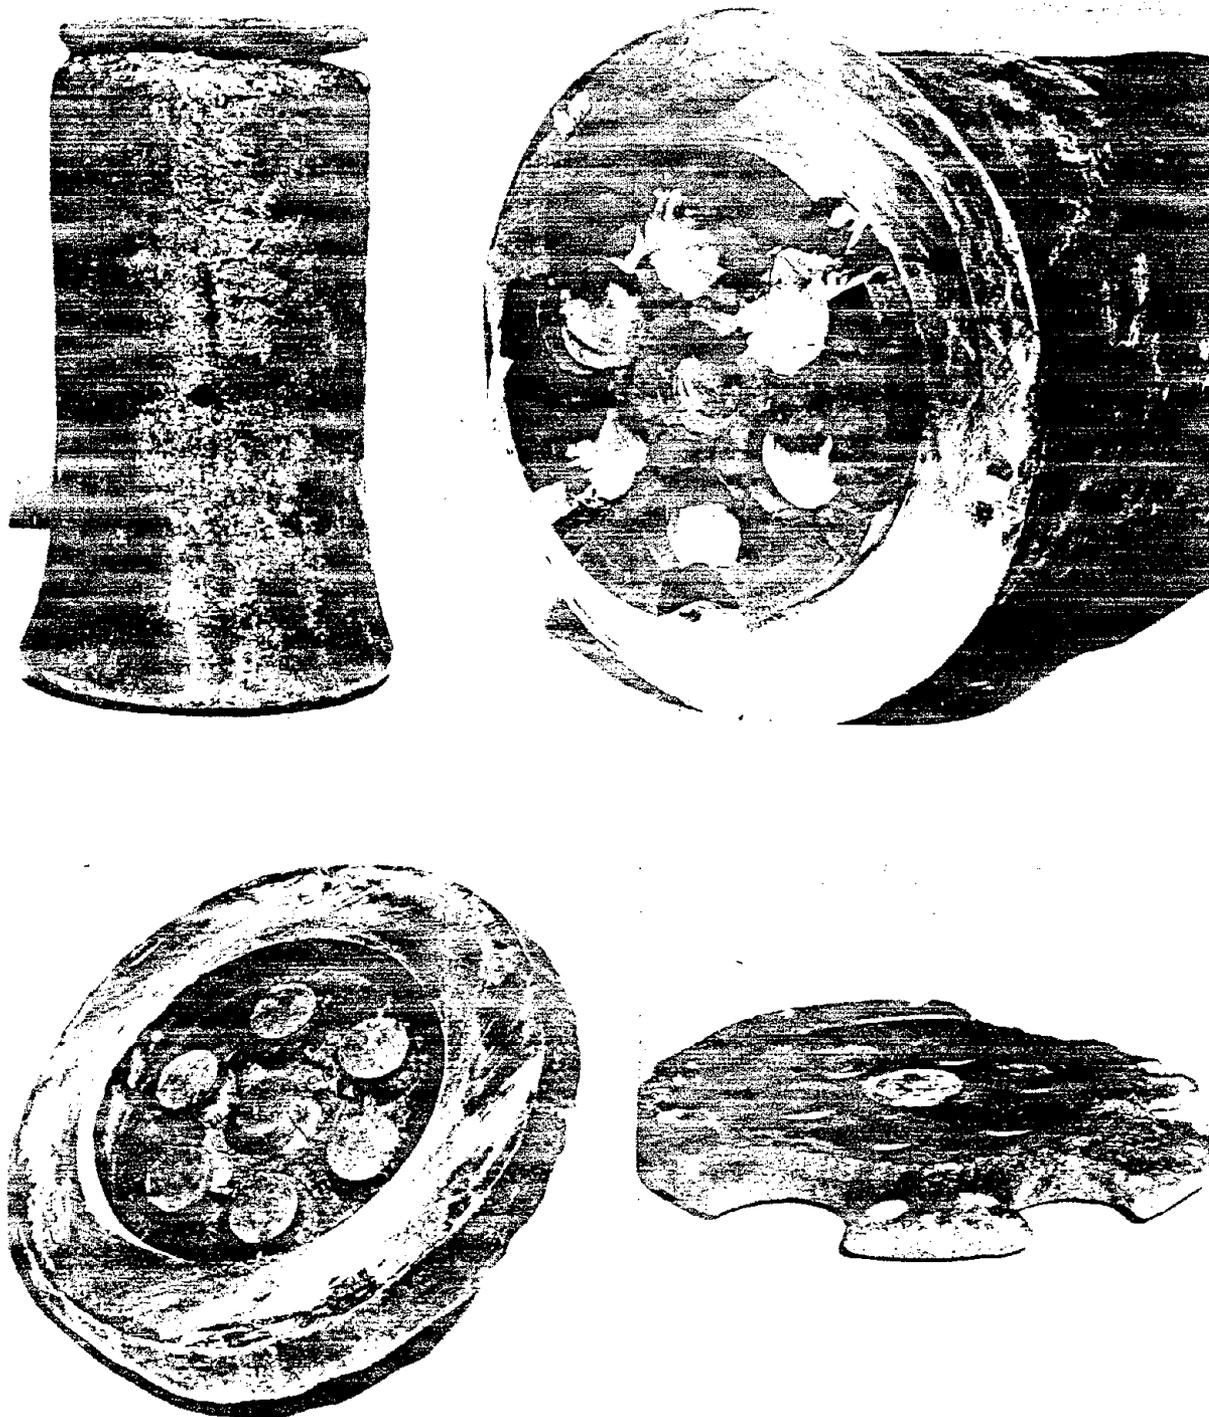
Figure A.20 Dynamic pressure cylinder, 50-foot station.

The dynamic-pressure cylinder at the 50-foot station was badly damaged by pressure forces. Details of this damage are presented in Appendix A.

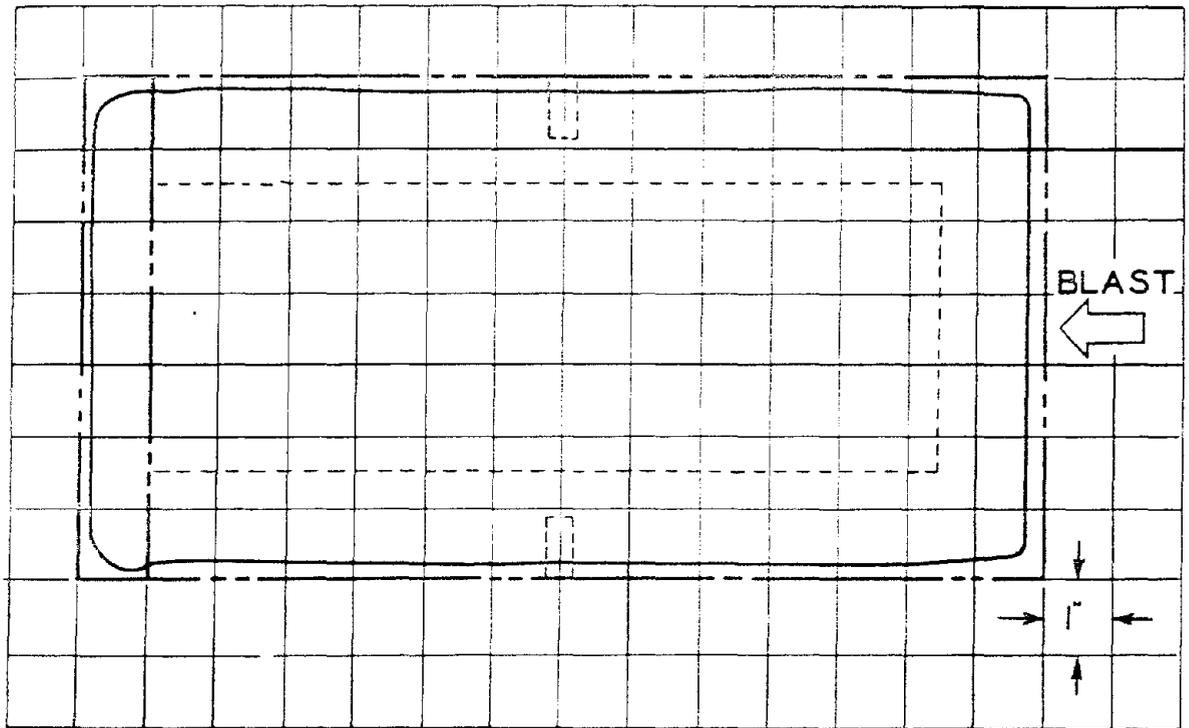
Figure A.25 Dynamic pressure cylinder, 250-foot station.

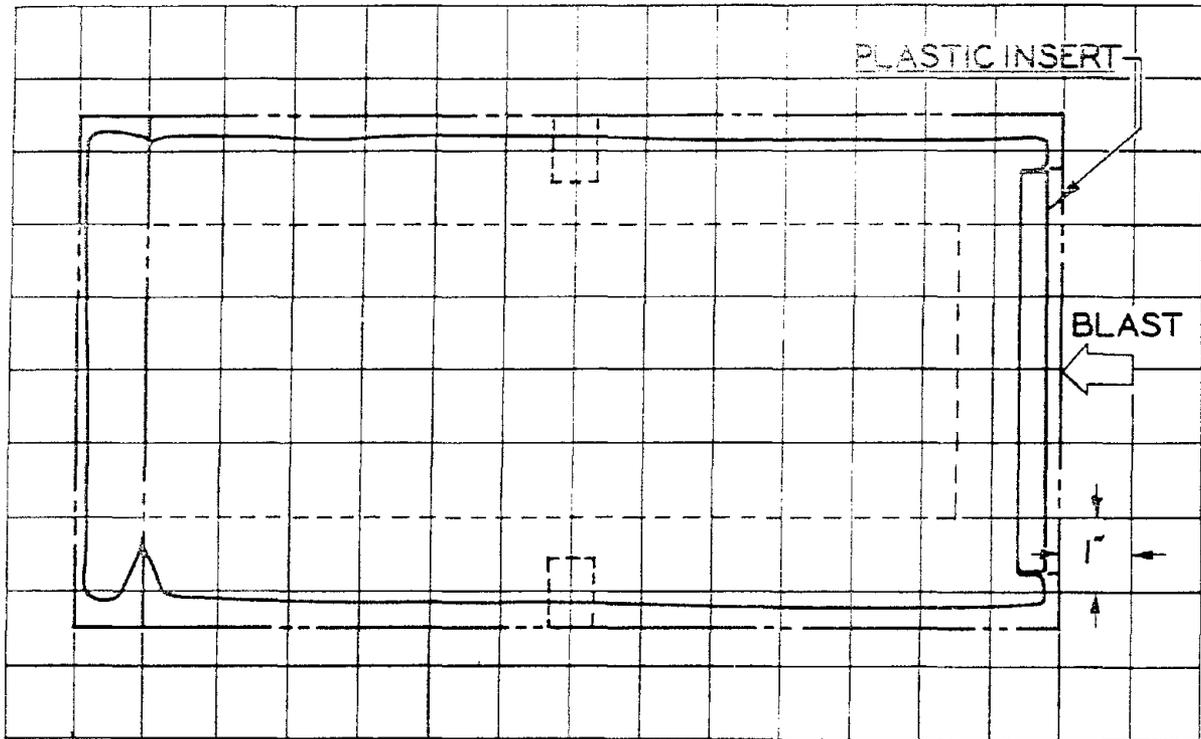
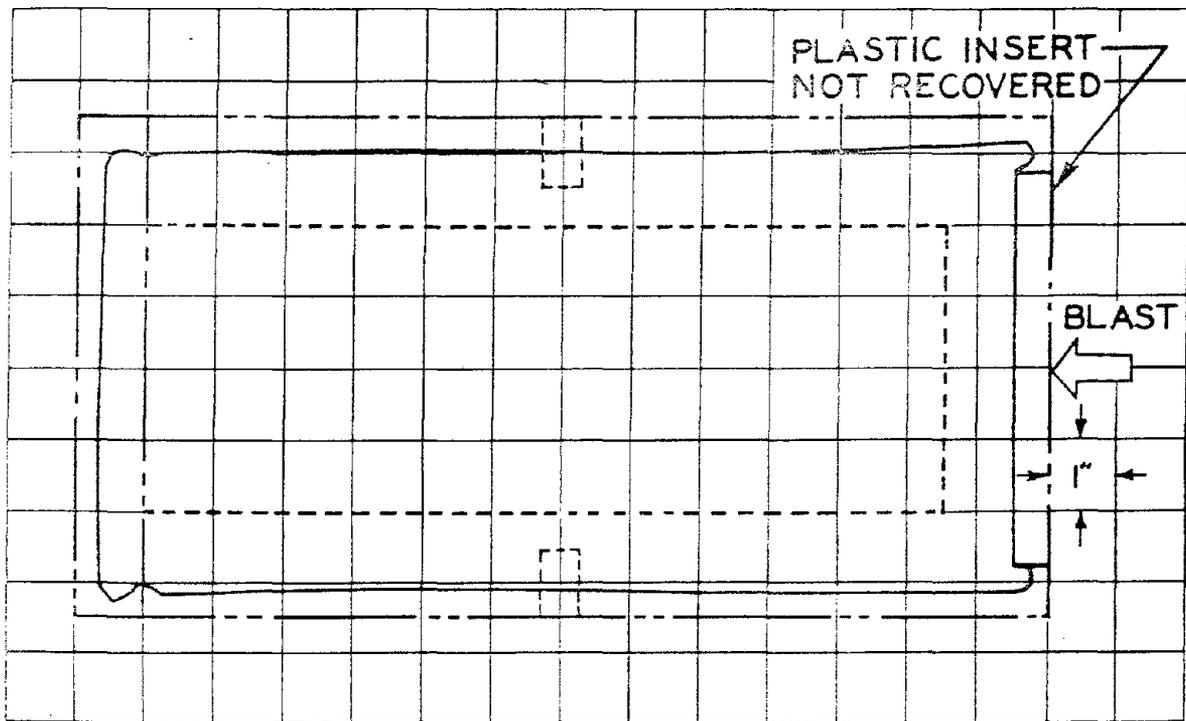
Figure A.27 Dynamic pressure cylinders with plastic disks, 150-foot station.

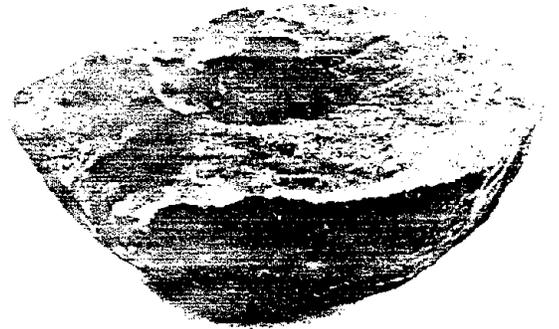
Figure A.35 Stainless steel sphere, 25-foot station.

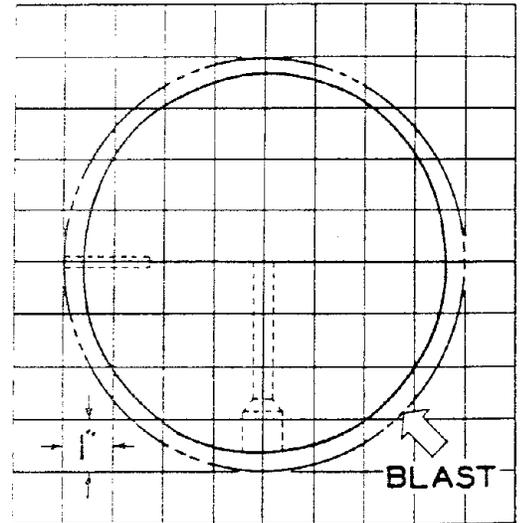
Figure A.36 Stainless steel sphere, 100-foot station.

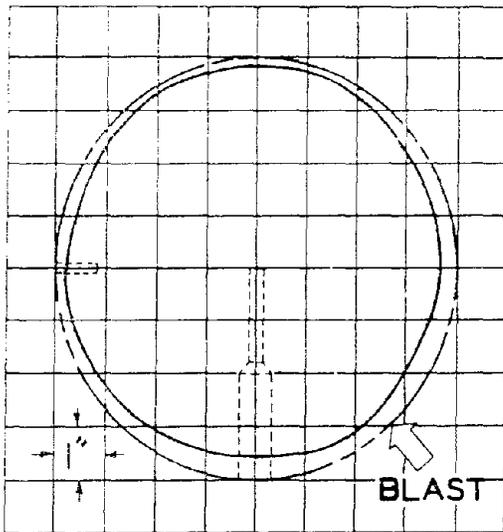
Figure A.37 Stainless steel sphere, 200-foot station.

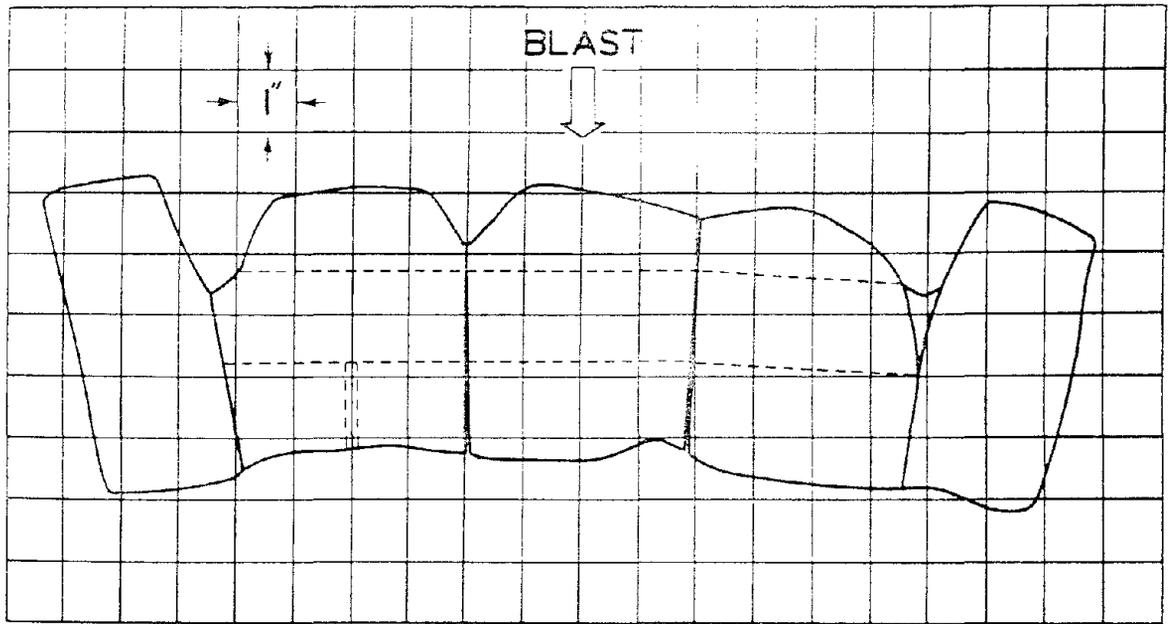
Figure A.40 Tantalum-copper cylinder, 100-foot station.

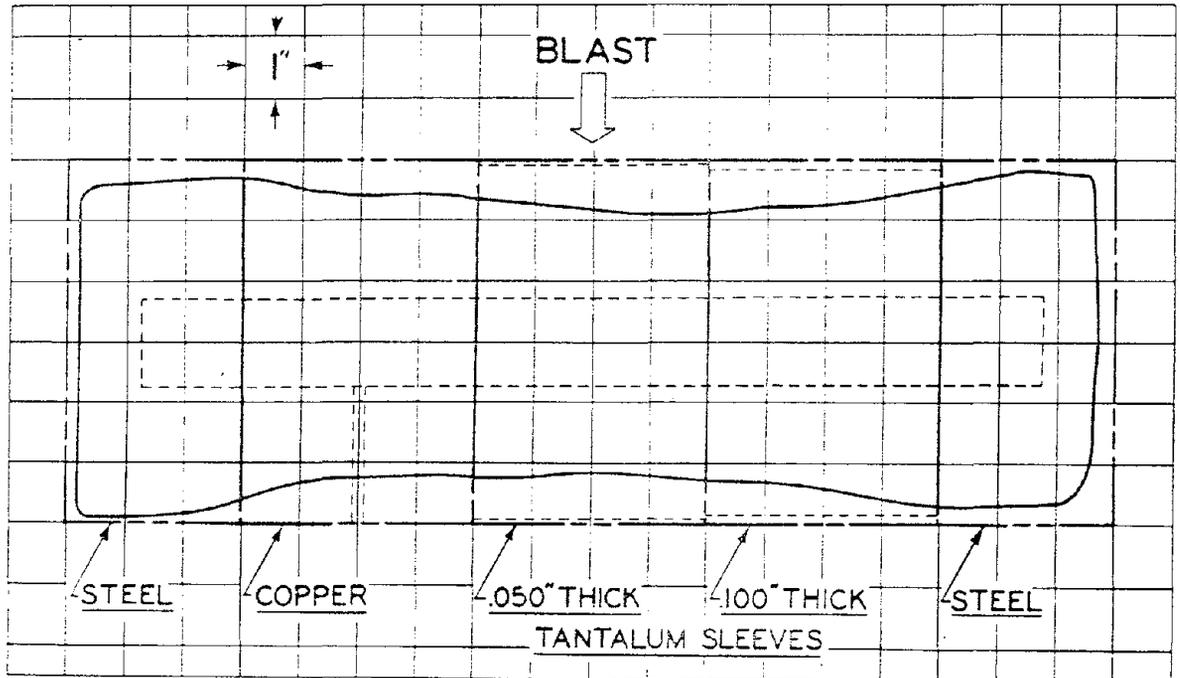
Figure A.41 Tantalum-copper cylinder, 200-foot station.

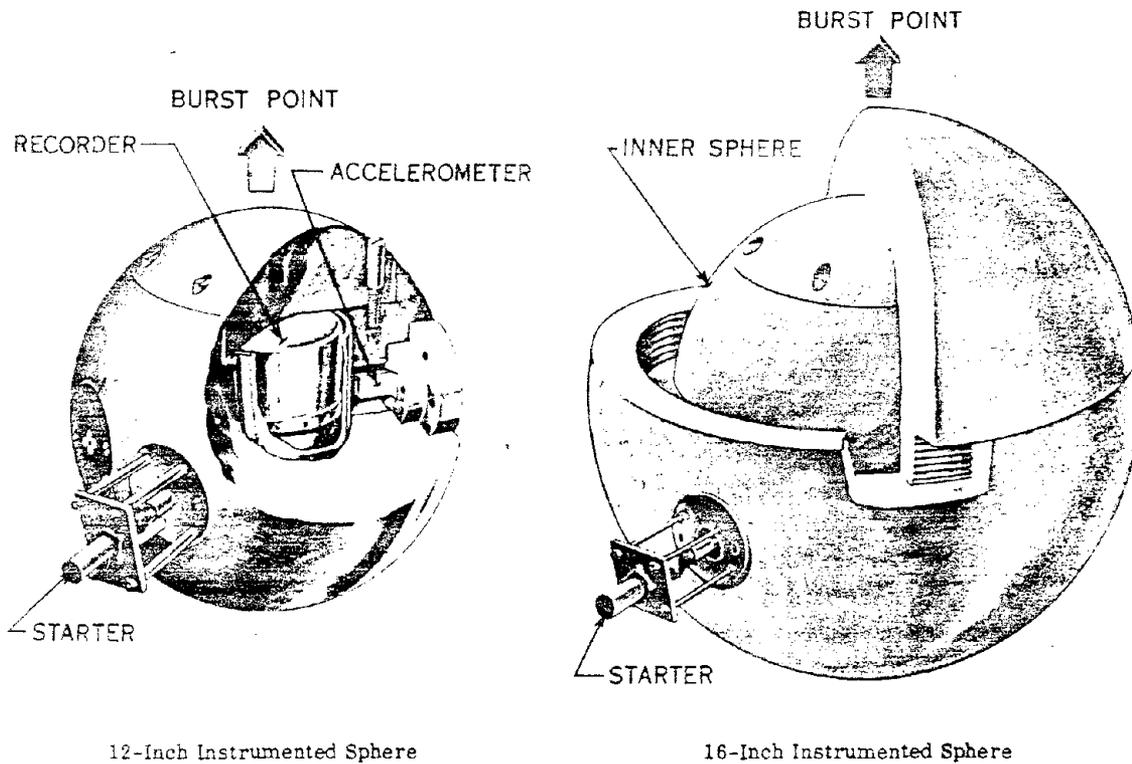
Figure B.2 Instrumented spheres.

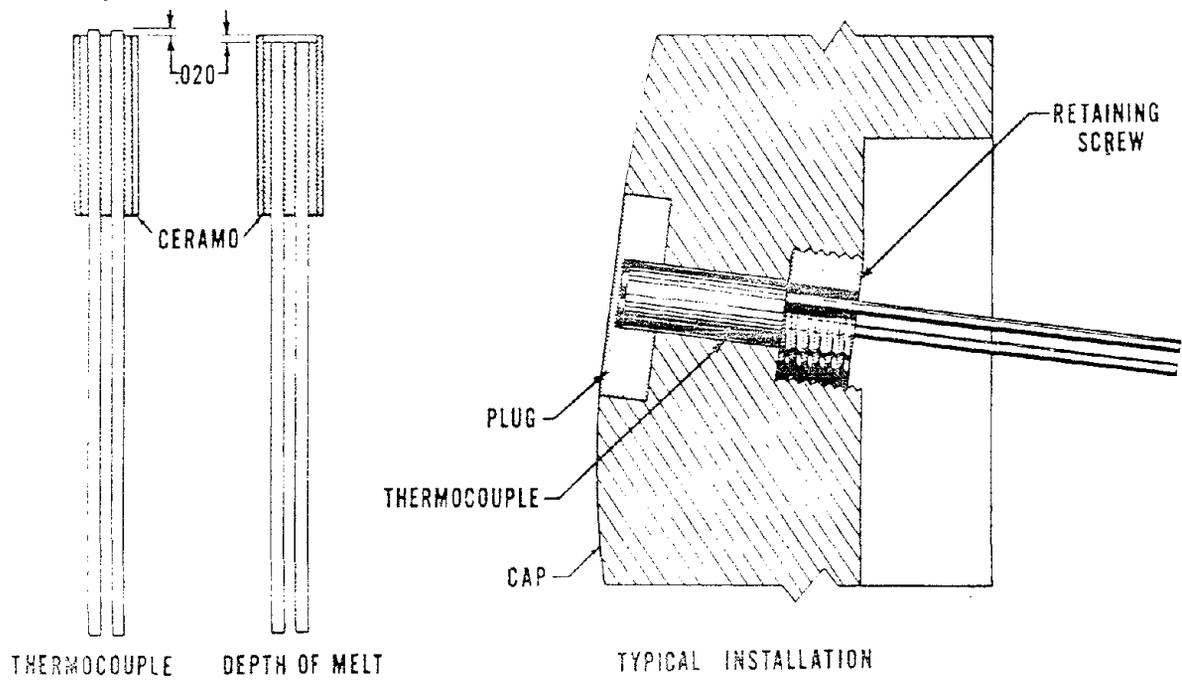
Figure B.4 Design and installation of thermocouple and depth-of-melt transducers.

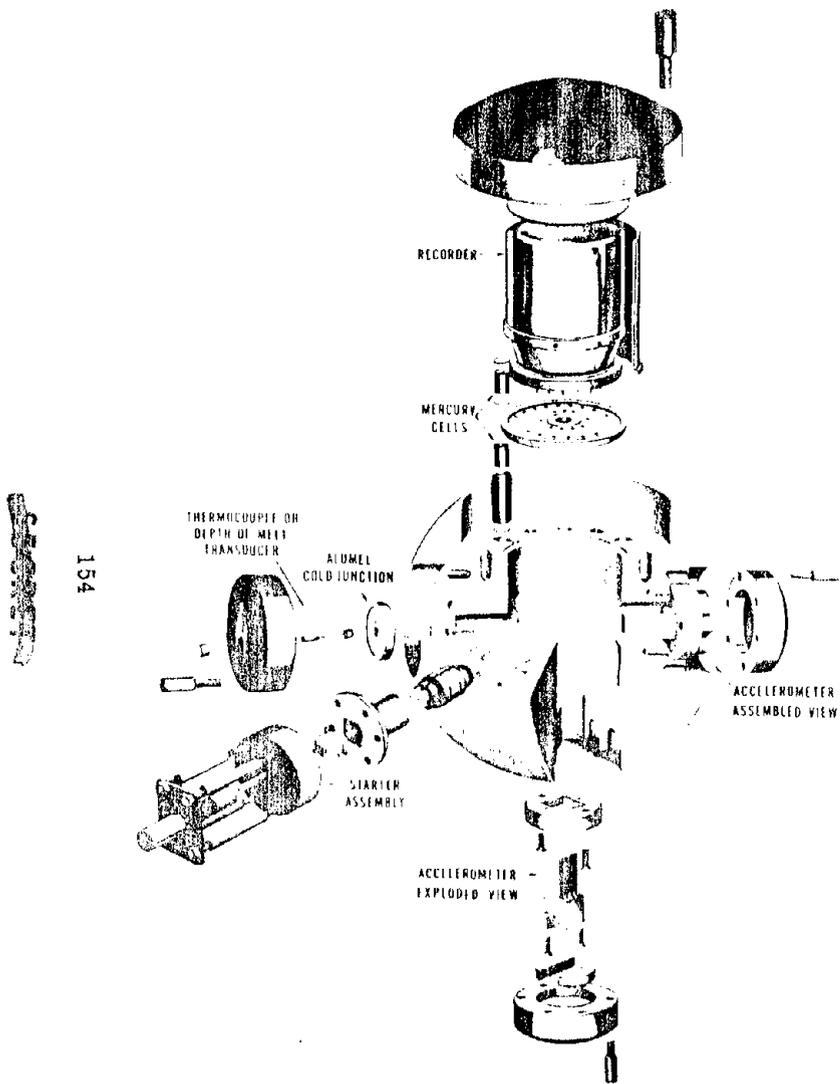
Figure B.5 Exploded view of a typical 12-inch instrumented sphere.

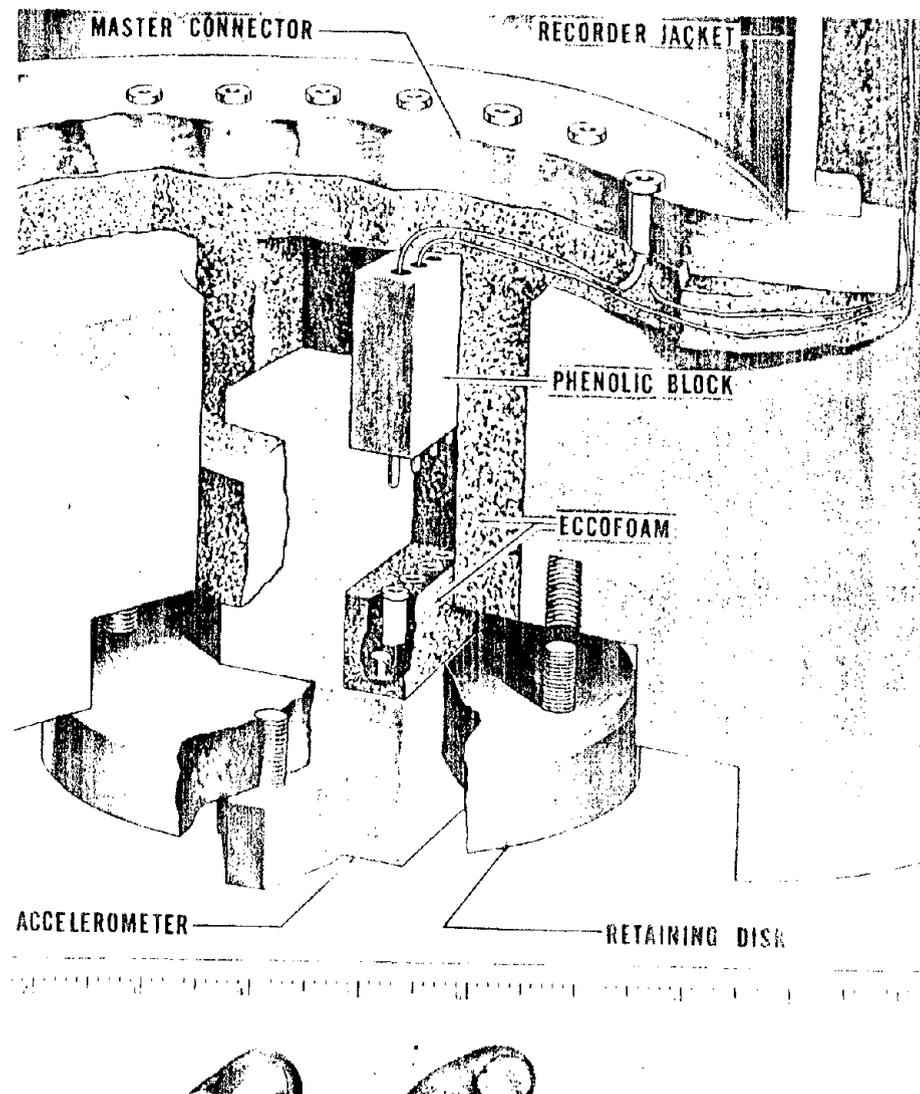
Figure B.6 Typical accelerometer installation showing eccofoam.

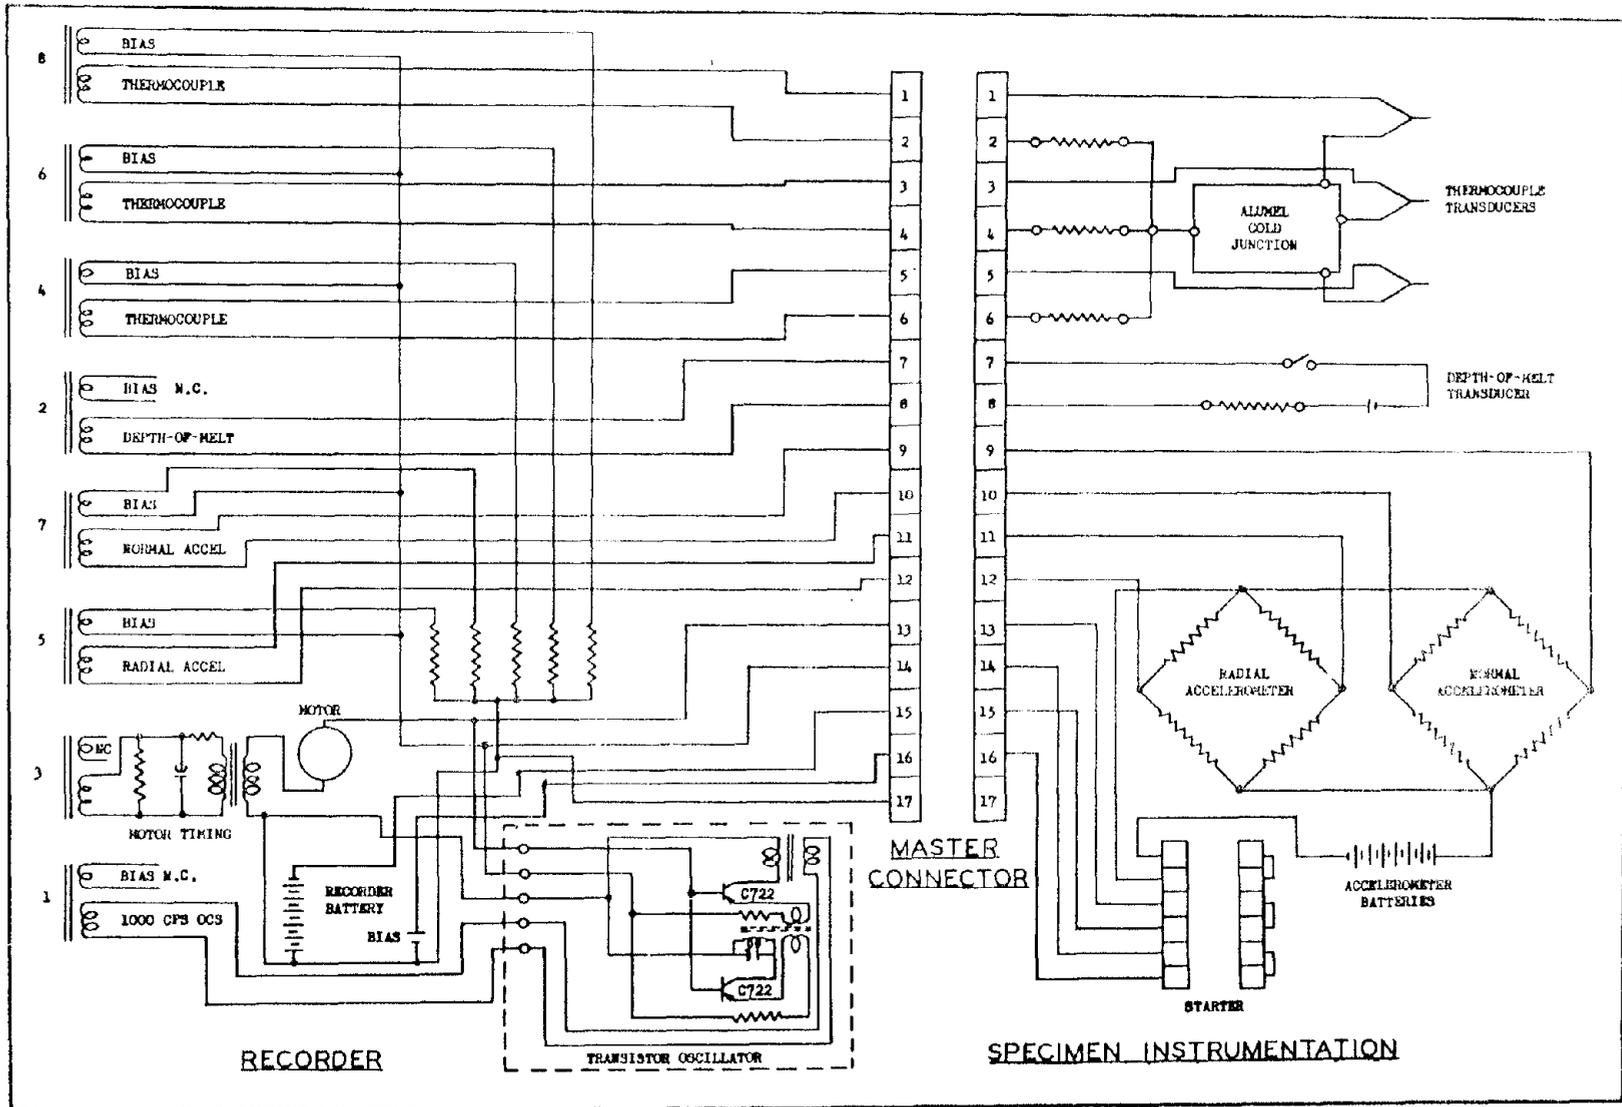
Figure B.7 Schematic wiring diagram of a typical 12-inch instrumented sphere.

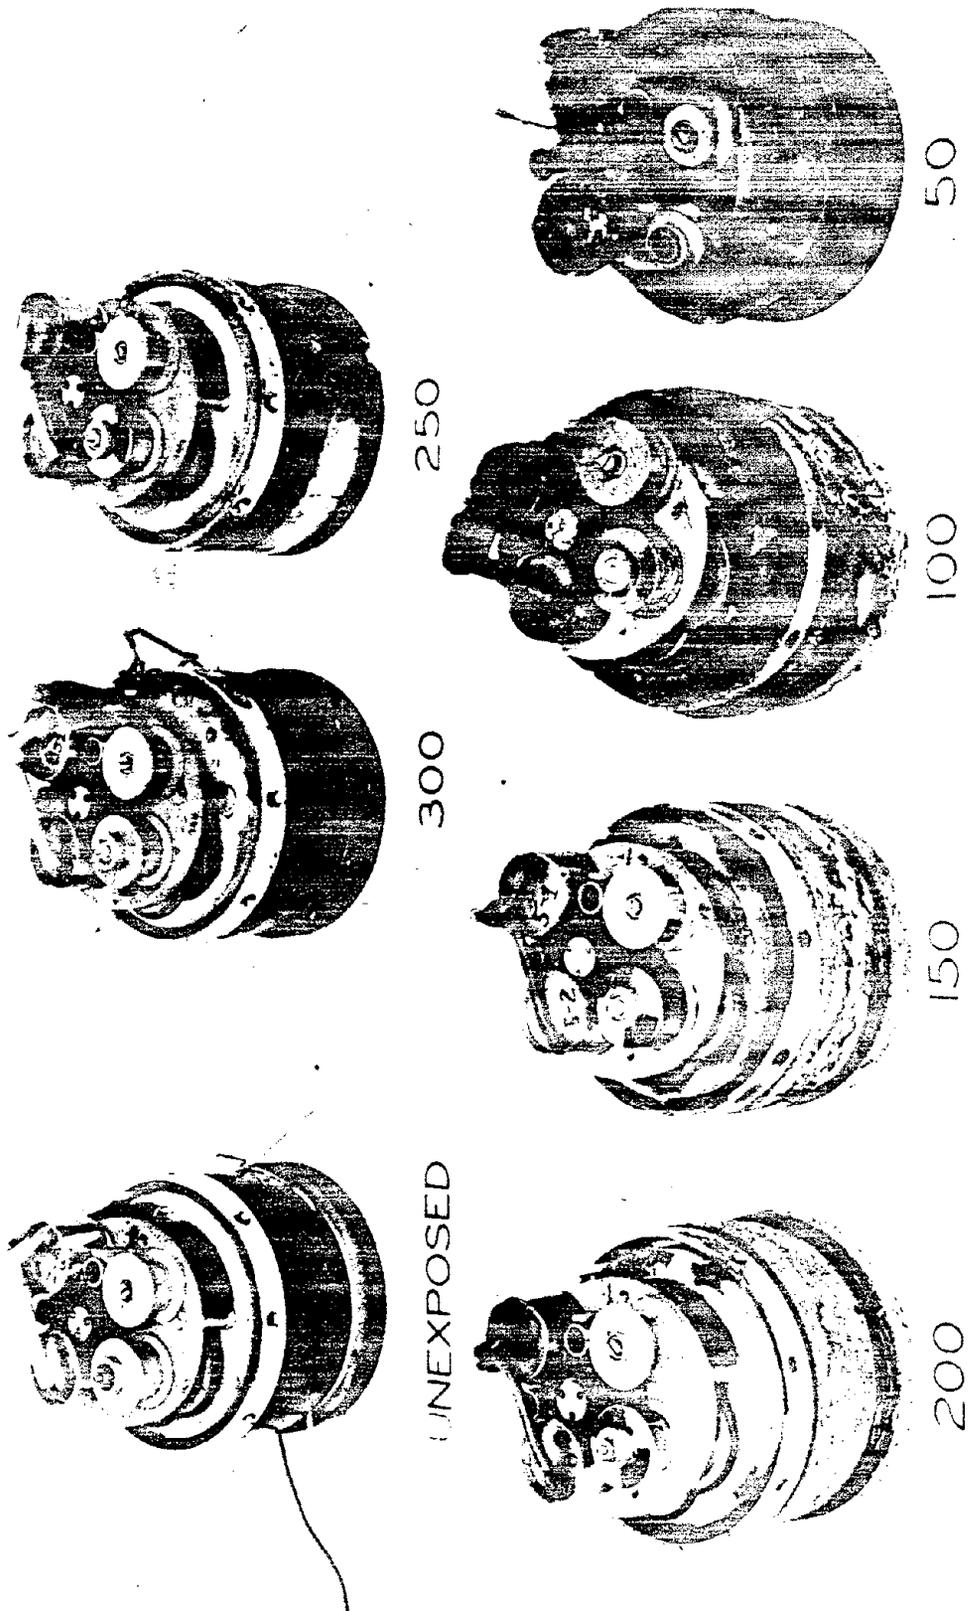
Figure B.8 Miniature recorder damage at Stations 50 through 300.

tion 50 through 300 as noted in Table B.4. Charring of components was the principle heat damage mechanism at Stations 50, 100, and 150, and melting solder was the predominant mechanism at Stations 200, 250, and 300. It should be noted that the heat damage was probably a delayed effect, since the peak temperature was not reached until some time after the specimen was in the ground, and therefore would not have prevented the instrument from functioning normally during the period of interest.

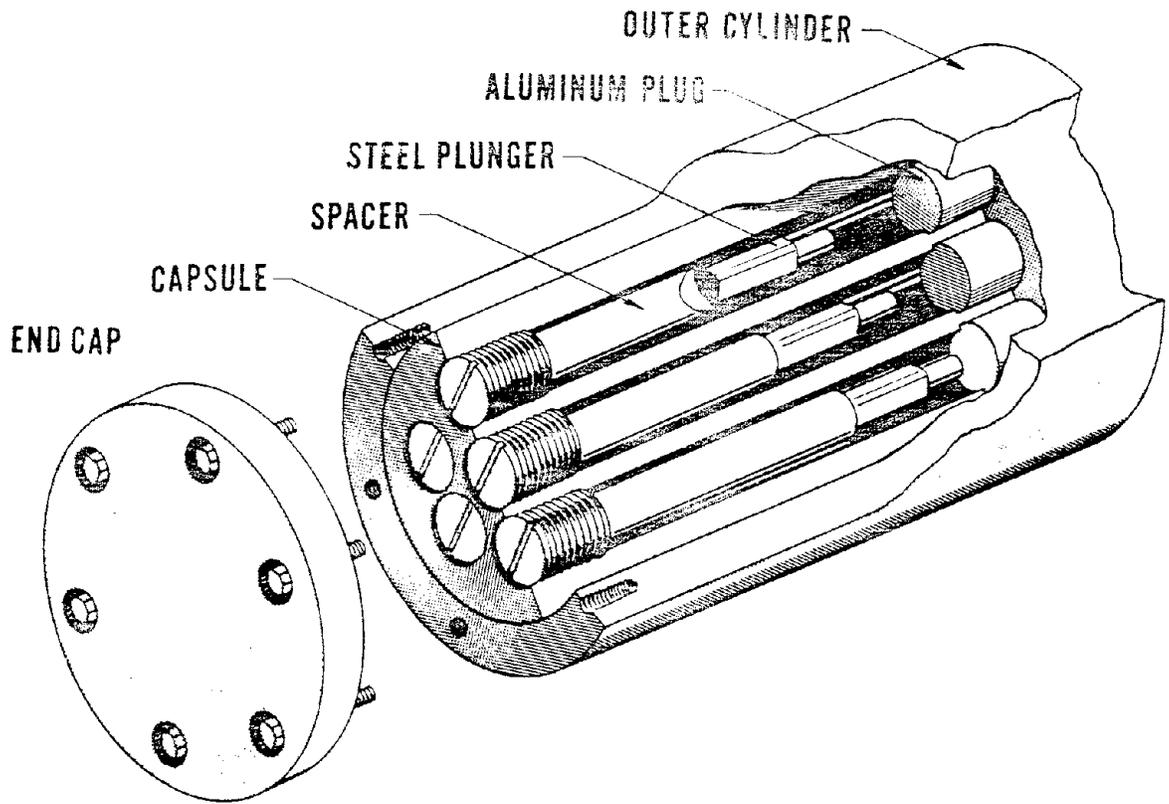
Figure C.1 Typical velocity-distance impact gage installation.

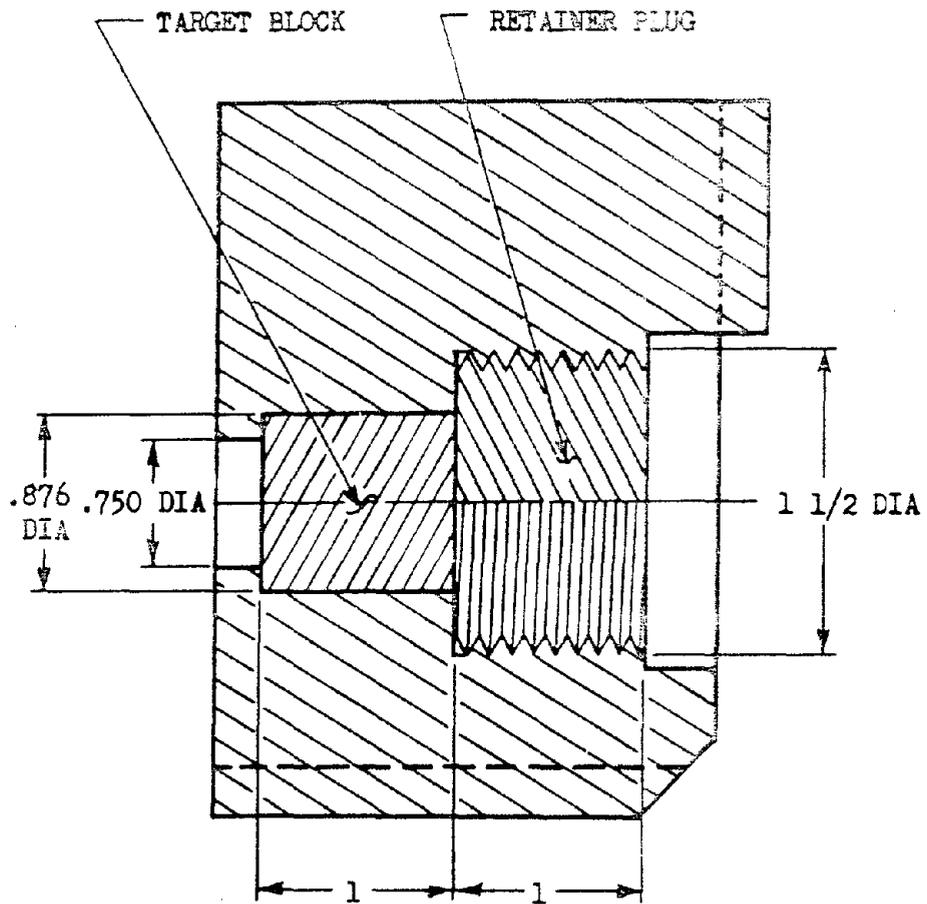
Figure C.3 Section drawing of target block holding fixture.

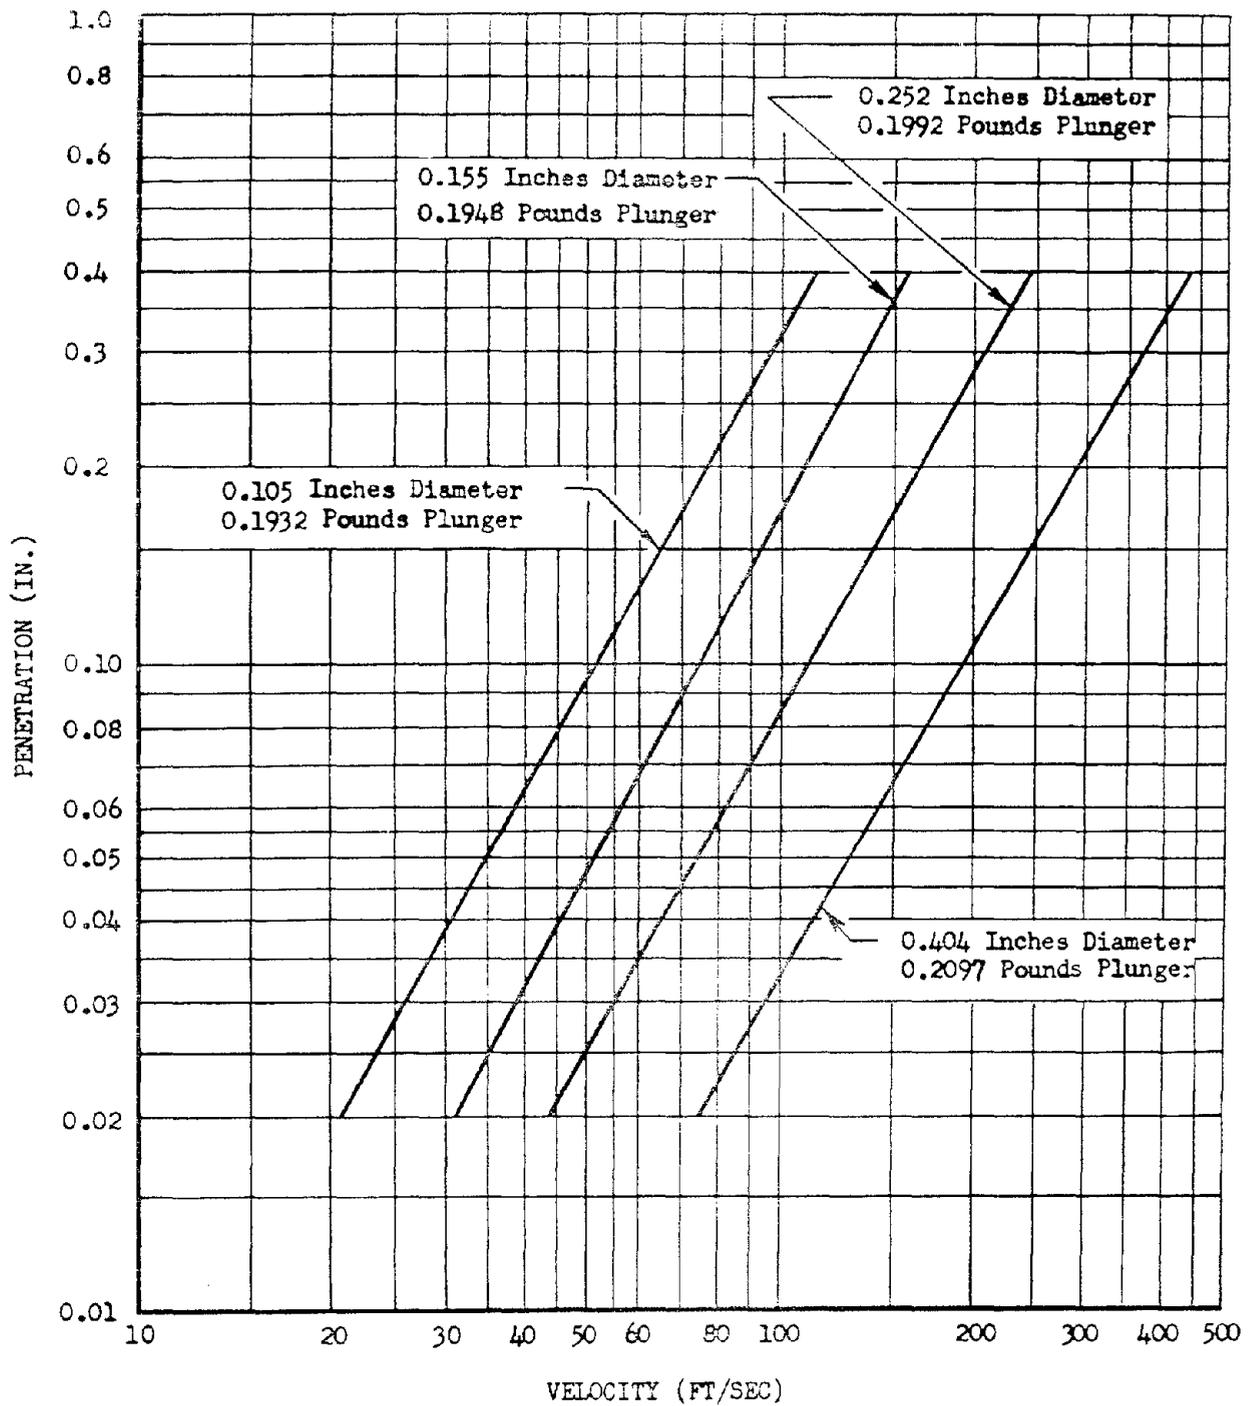
Figure C.5 Penetration versus velocity for 1/2-inch-thick 2S aluminum impact blocks.

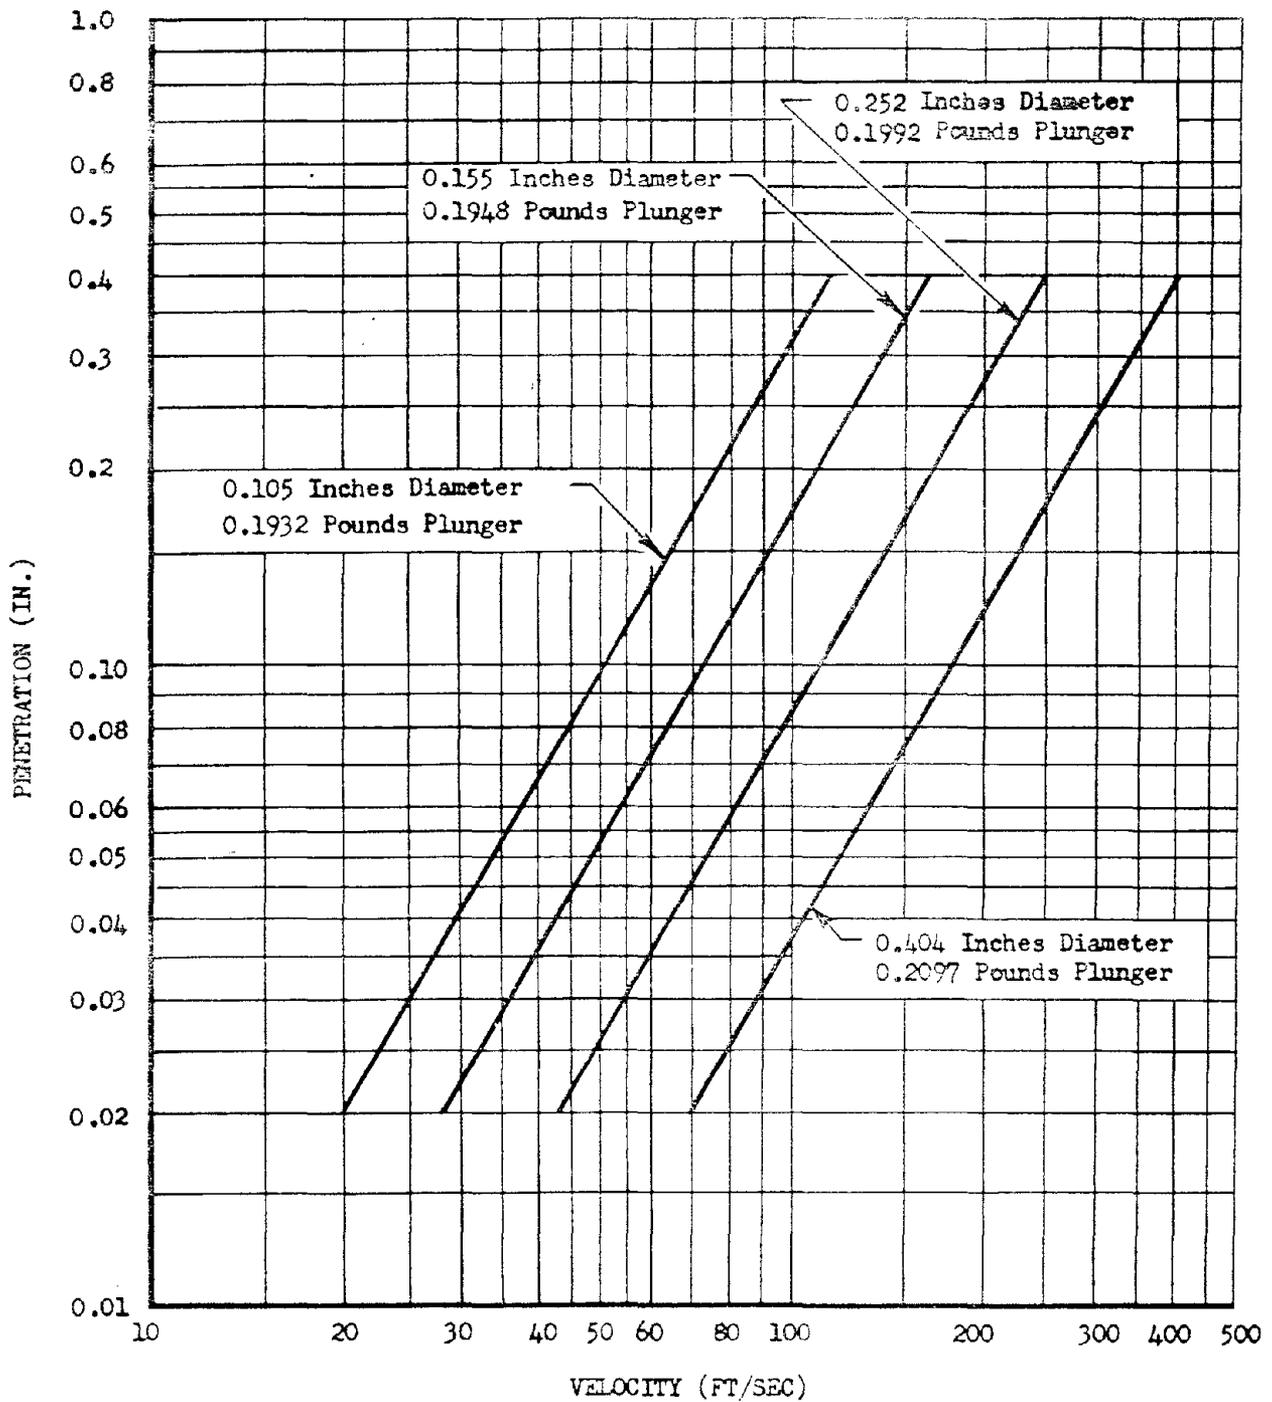
Figure C.6 Penetration versus velocity for 1-inch-thick 2S aluminum impact blocks.

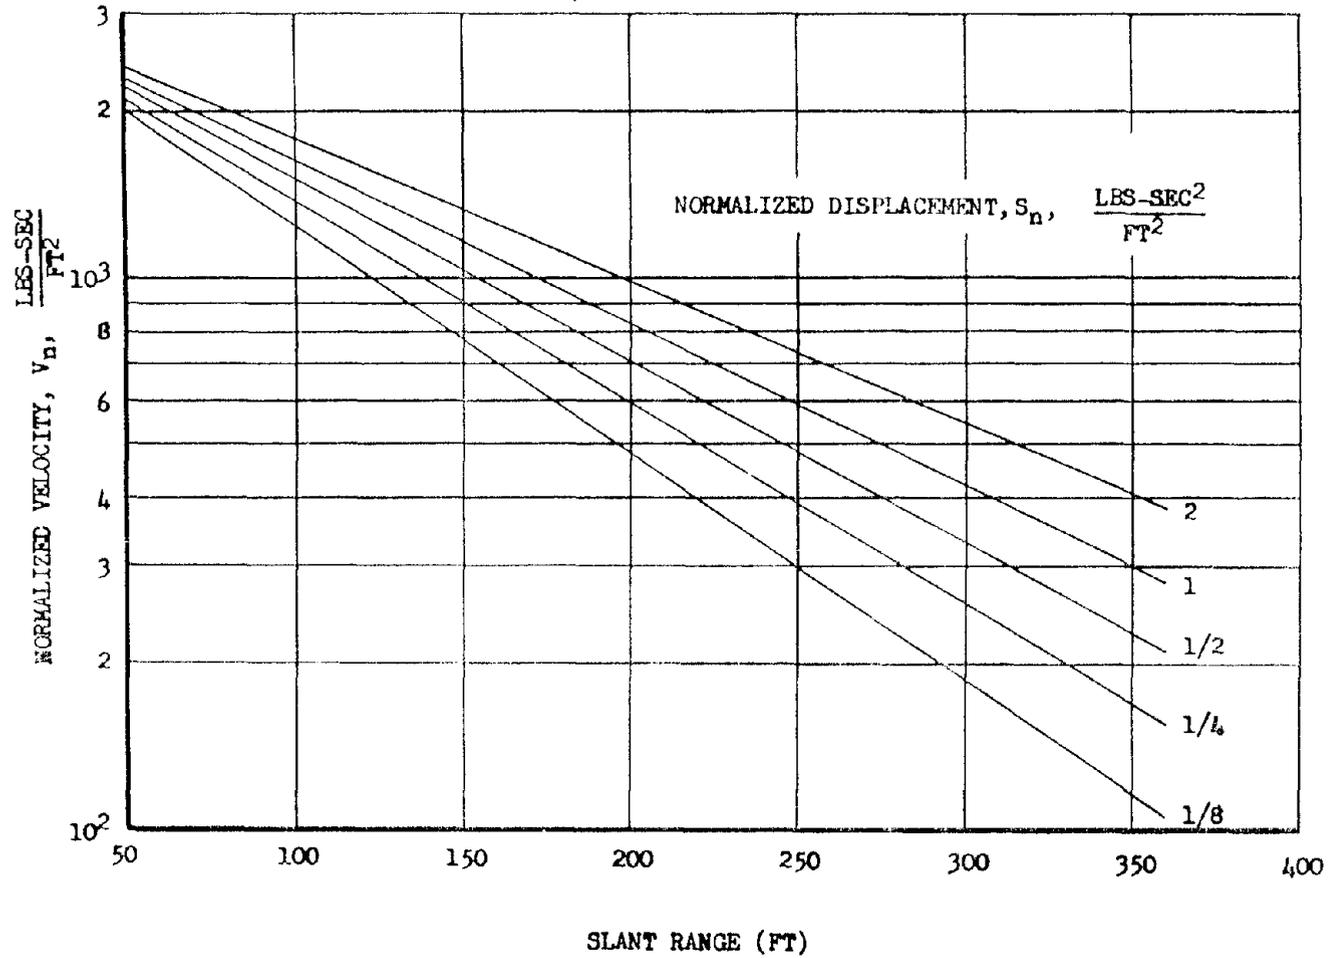
Figure C.7 Normalized velocity as a function of slant range for normalized displacement up to 2 inches for a 10 kt yield.

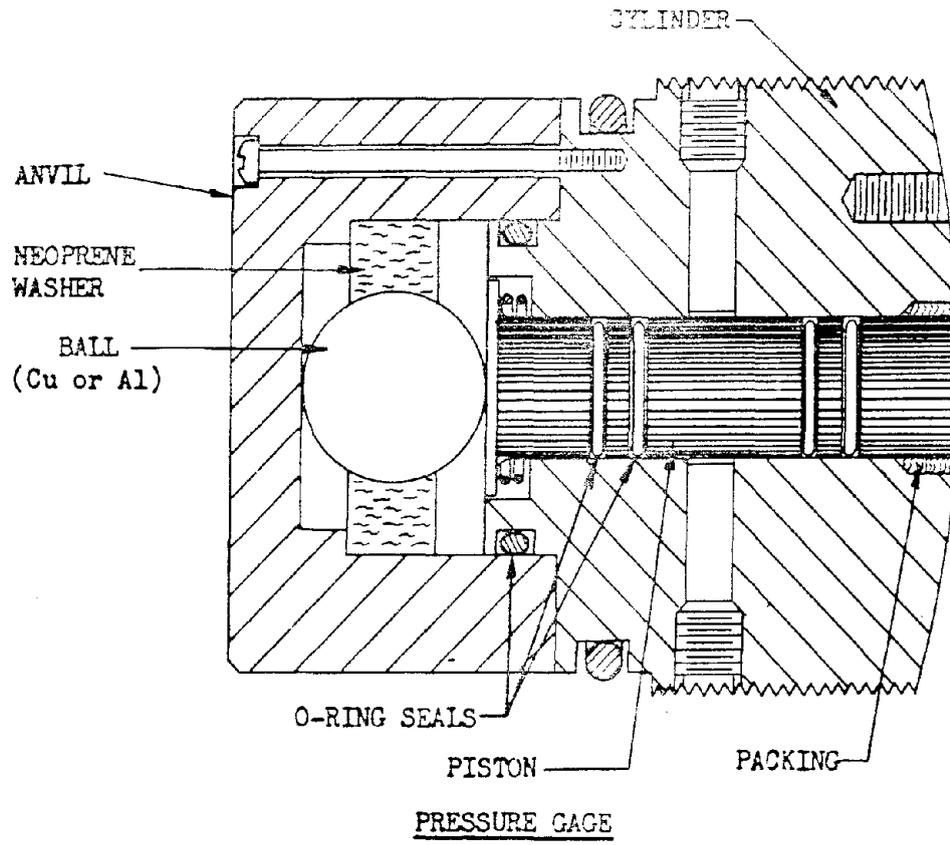
Figure D.1 Ball-crusher pressure gage.

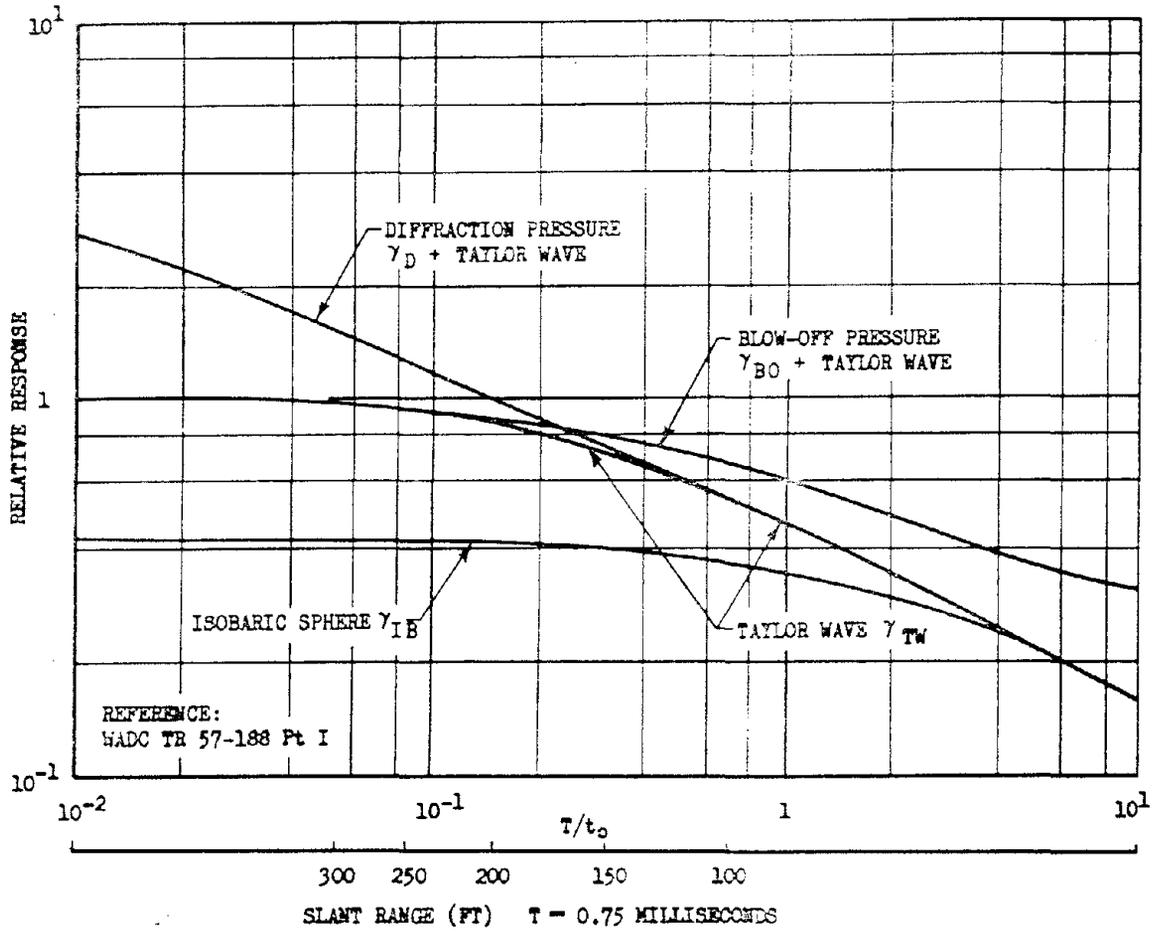
Figure D.5 Relative response of ball-crusher gage to various inputs. Relative response, γ versus ratio of gage period (T) to time of shock arrival (t_0), T/t_0 .
